**Expansion of Sha Tau Kok Sewage Treatment Works**

**Environmental Team Services for Construction Phase (2020-2021)**

**Quarterly EM&A Summary Report for December 2020 to February 2021**

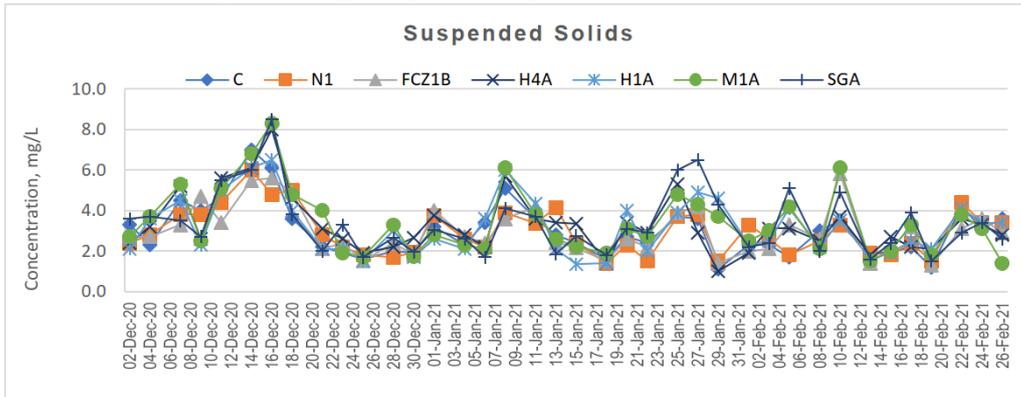
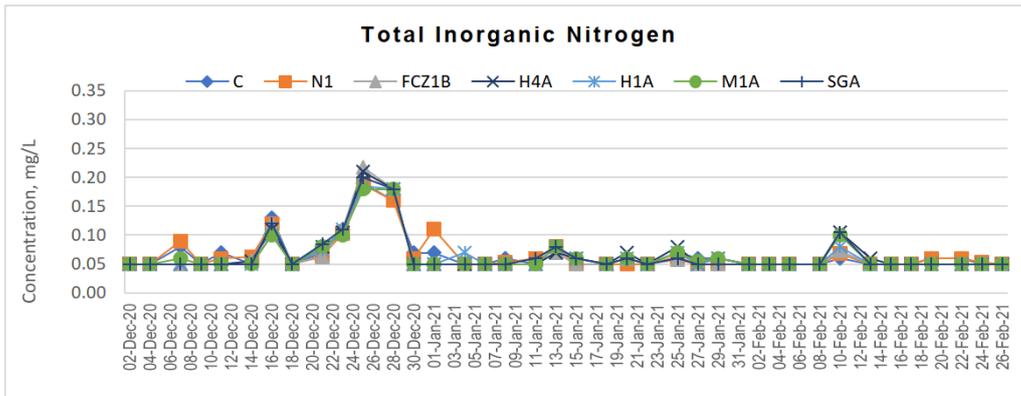
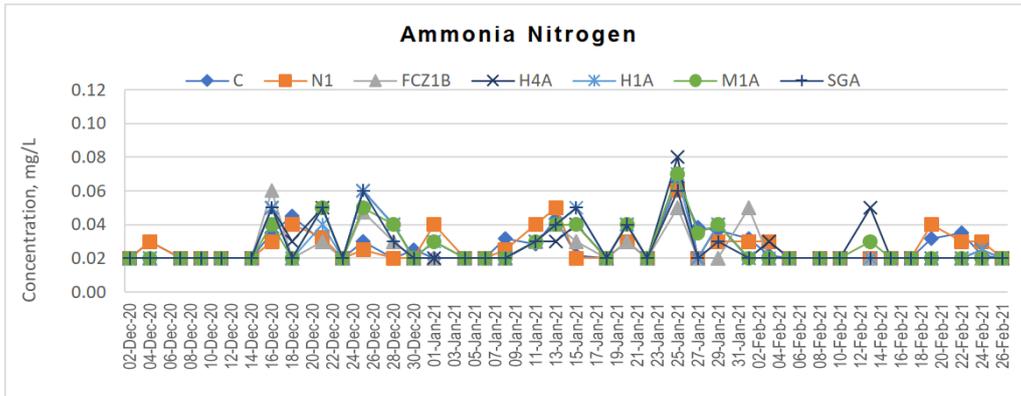
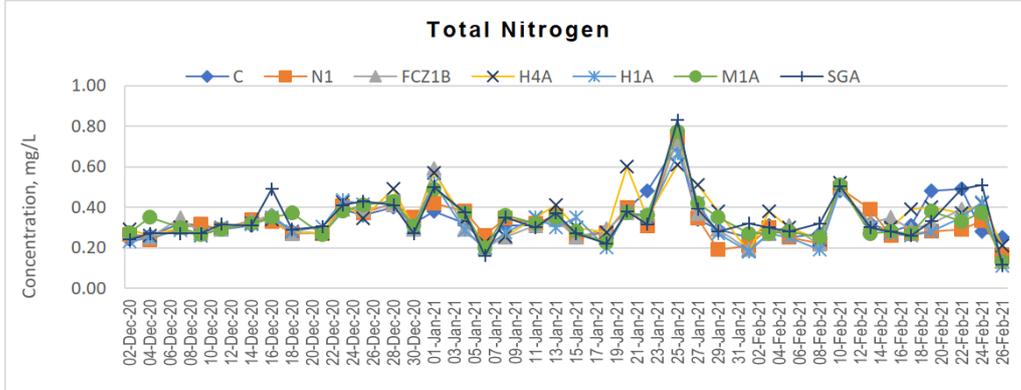
**Marine Water Quality Monitoring for 1-year TSTP Operation**

\*For Total Inorganic Nitrogen, the <0.05 will be presented as value of 0.05 in the plot.

\*For Ammonia Nitrogen, the <0.02 will be presented as value of 0.02 in the plot.

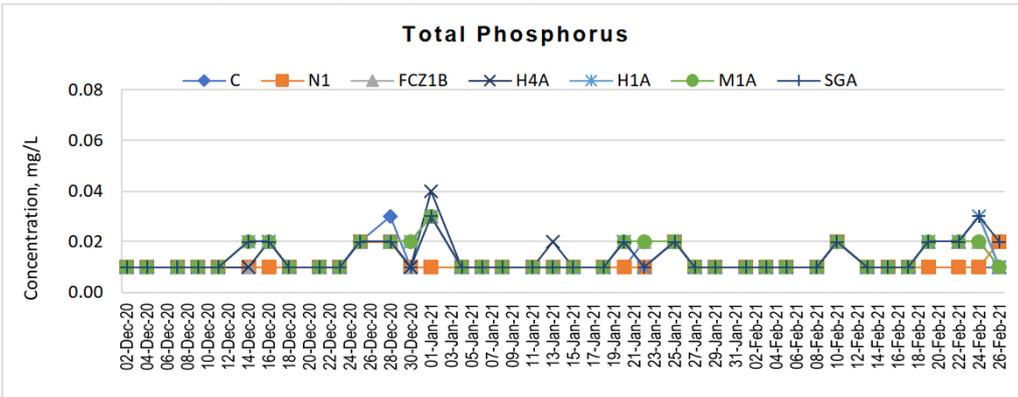
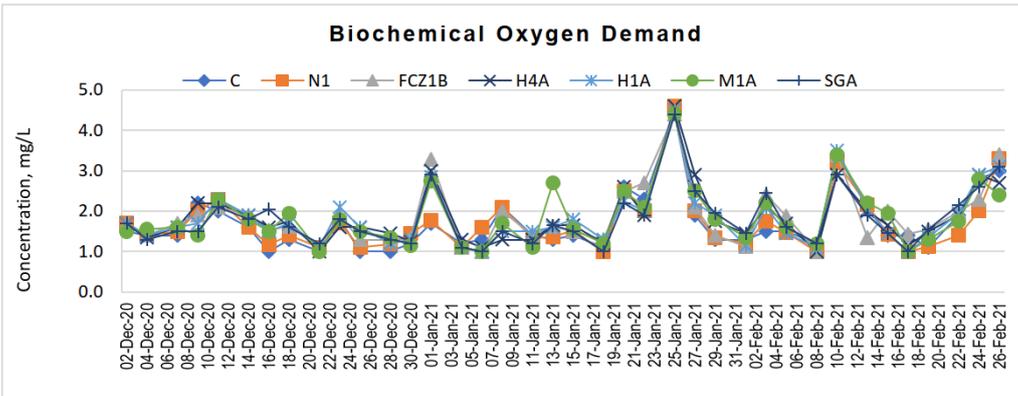
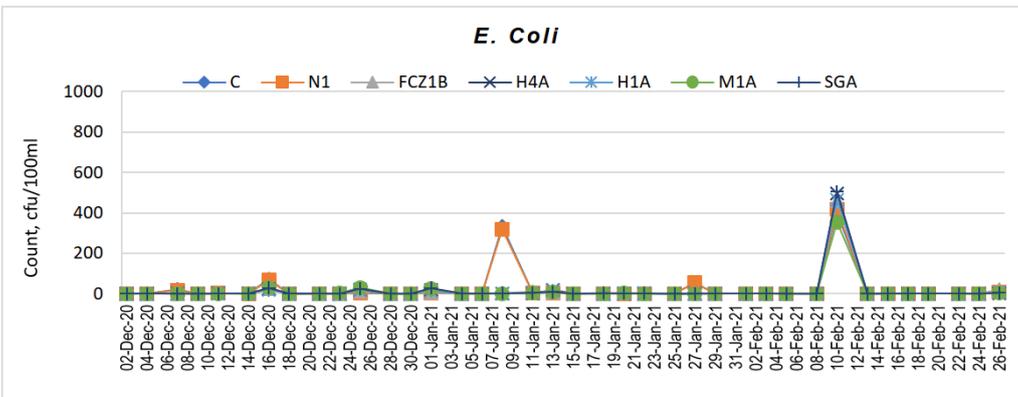
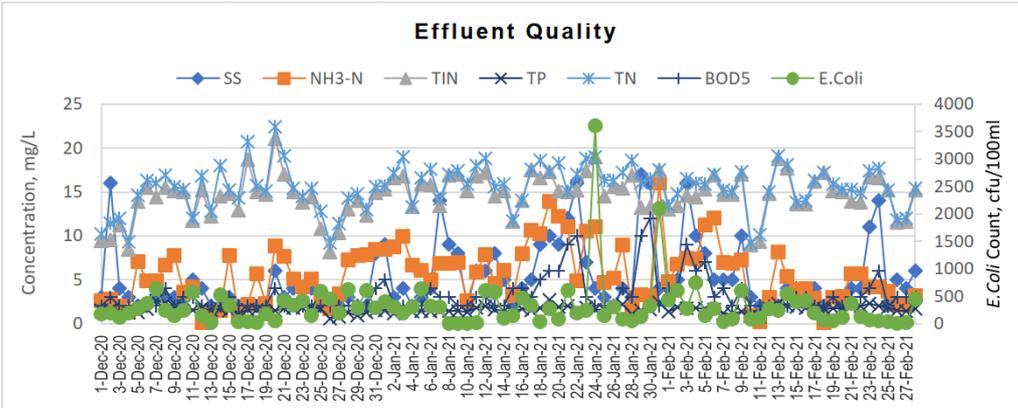
### Marine Water Quality Monitoring for 1-year TSTP Operation

For E.Coli, the Not Detected will be presented as zero in the plot.
